Docket No. 217 – Development and Management Plan Inspection

Northeast Utilities Service Company Certificate of Environmental Compatibility and Public Need for the construction of a 345-kV electric transmission line and reconstruction of an existing 115-kV electric transmission line between Connecticut Light and Power Company's Plumtree Substation in Bethel, through the towns of Redding, Weston, and Wilton, and to the Norwalk Substation in Norwalk, Connecticut.

Date: October 21, 2004

Location: Norwalk Substation Expansion

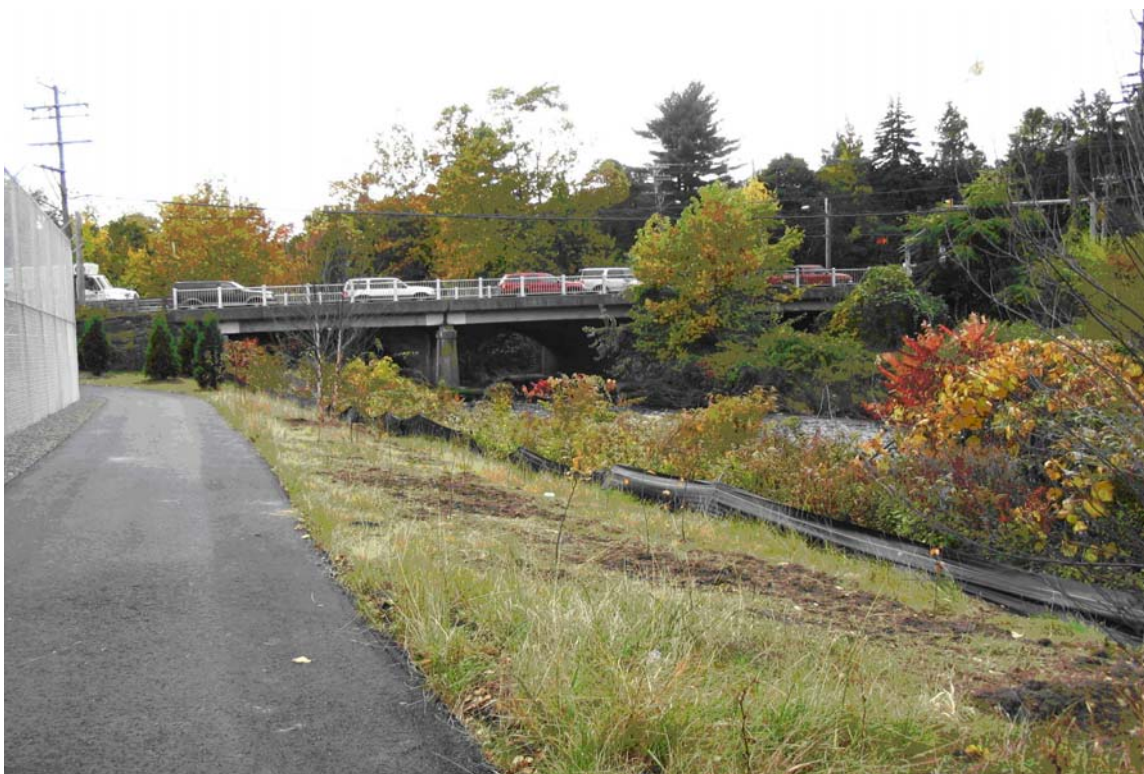
View of some of the landscaping and plantings along the Norwalk River and the bike path on site. The area looks very good with the new work. 10/21/04

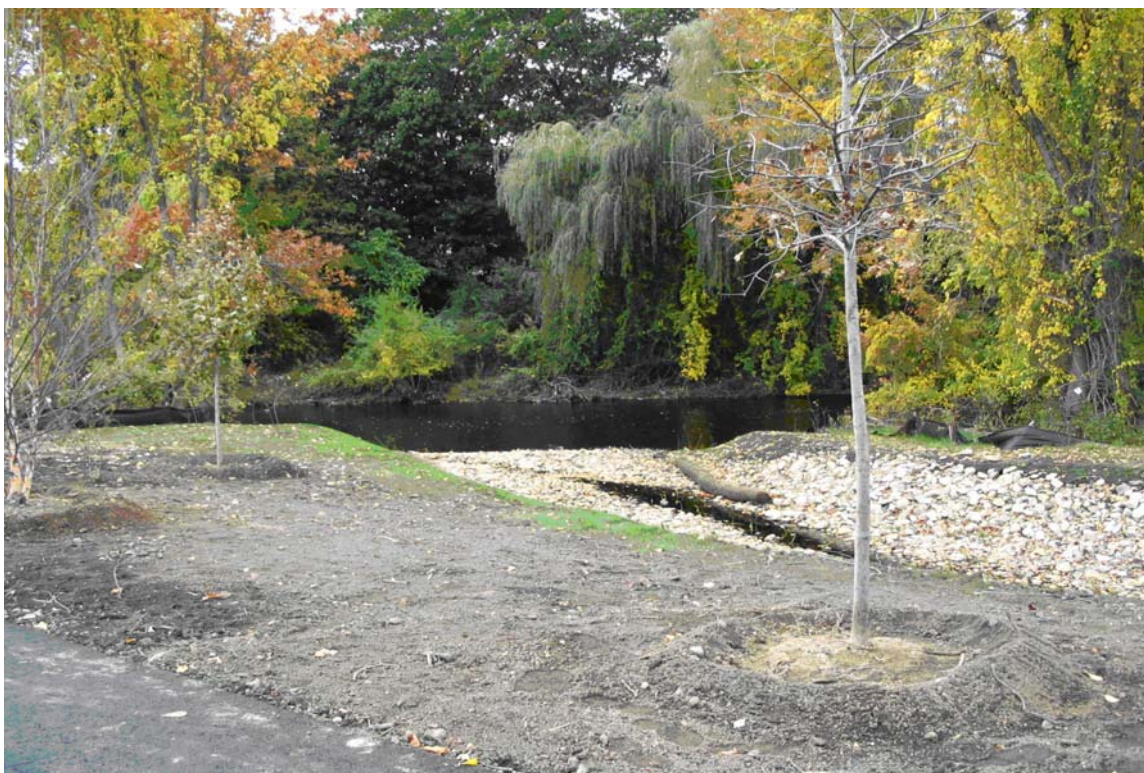
View of the southern portion of the overflow channel where some of the landscaping was recently completed. A straw mulch may help stabilize the area and promote vegetative cover sooner. 10/21/04

Inland Wetland and Watercourse encroachment and mitigation	- Most areas have sufficient vegetative cover but a few areas remain sparse. Some additional growth had occurred but the areas adjacent to and within the channel especially need stabilizing cover. 10/21/04	- Continue to monitor silt fence and repair as necessary, especially in the portions closest to the river. Fence could be removed from areas with sufficient cover. 10/21/04
State species of concern, threatened and endangered species	- No species of concern are located in this area of construction.	- N/A
Vegetative clearing limits (including trees to save or danger trees noted)	-Landscaping and planting of native species has occurred here and the area looks very good. River birch (<i>Betula nigra</i>) is one of the	- Focus should be on trying to get sparsely vegetated areas to get sufficient growth before the winter. Placement of straw mulch may help to promote

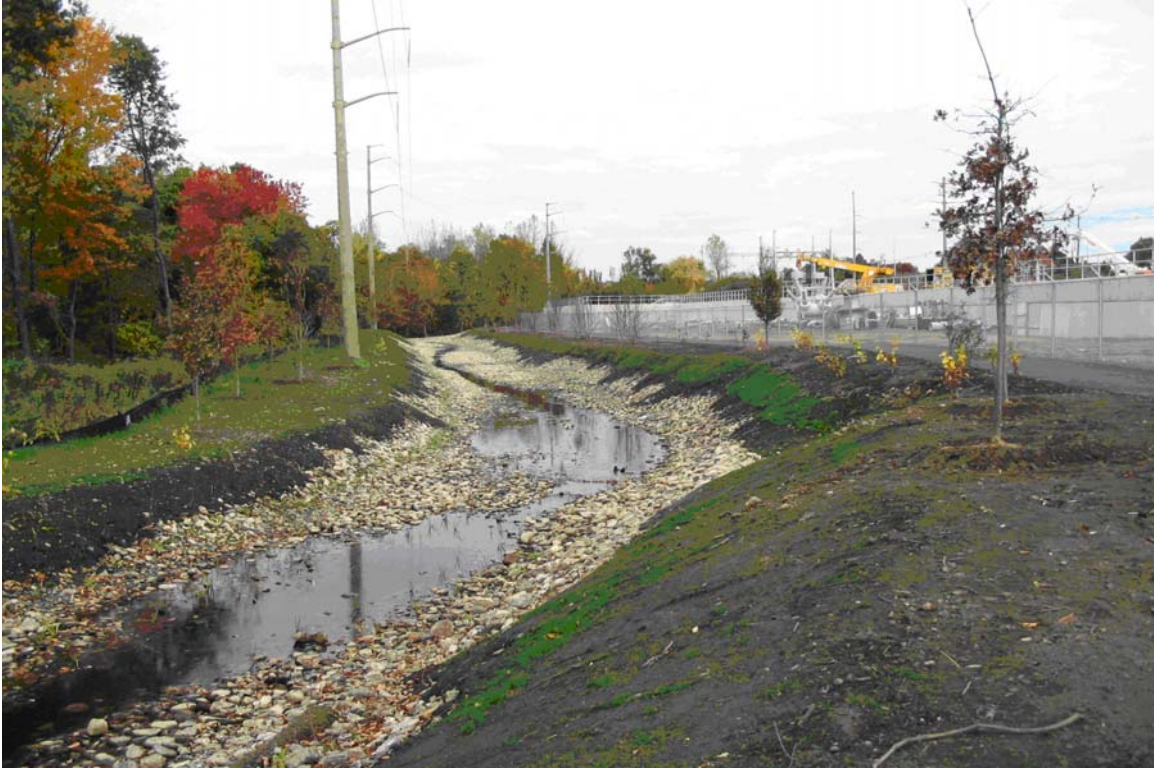
Small amounts of vegetative cover are growing in portions of the channel. The area was recently landscaped and trees and small seedlings were planted. Placing straw mulch may help with future cover. 10/21/04

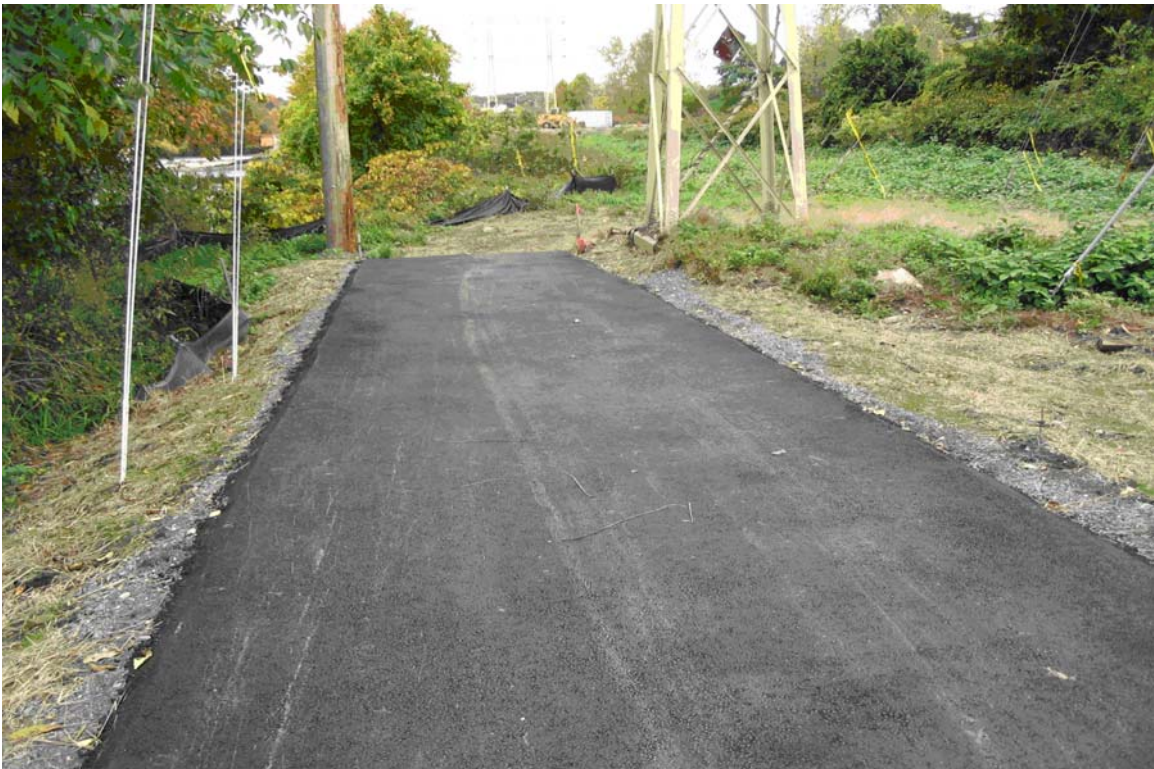
View of the northernmost portion of the bike path beyond the perimeter fence. The erosion in this area was obstructed by completing the bike path with paving. 10/21/04

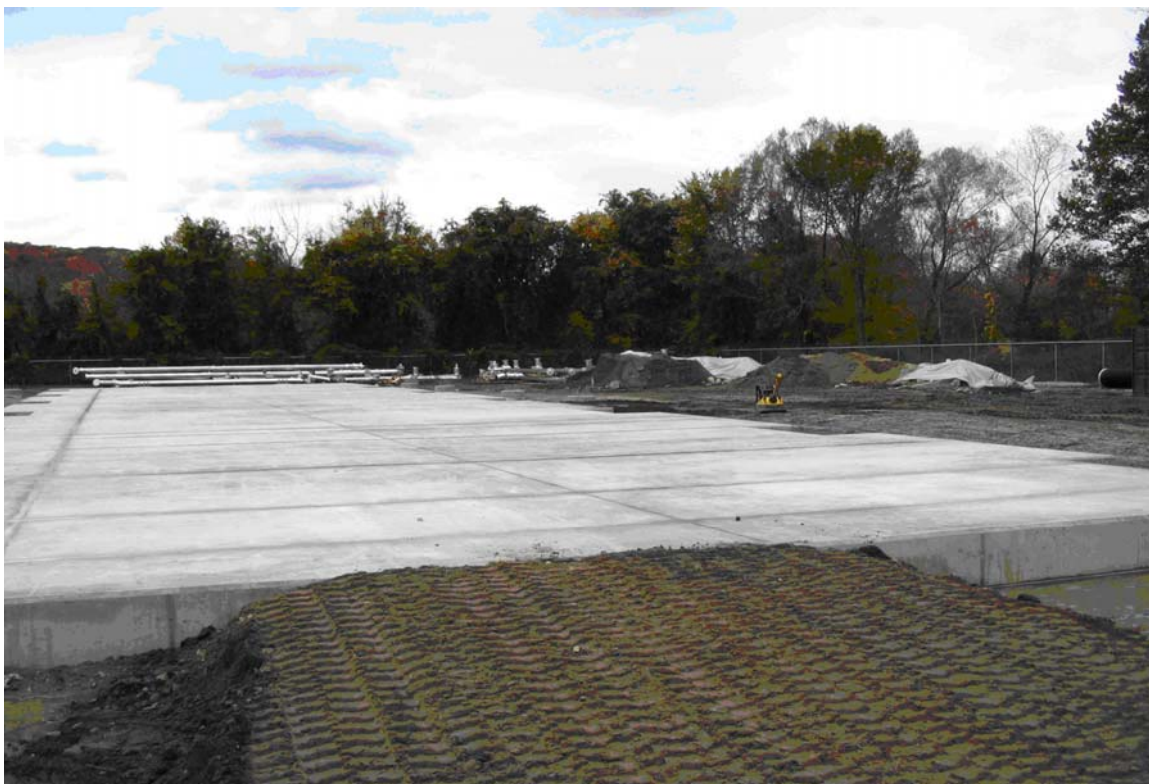
Plumtree Substation: View of the recently poured concrete pad for the GIS building with the small soil stockpiles in the background. All areas on site are contained. 10/21/04

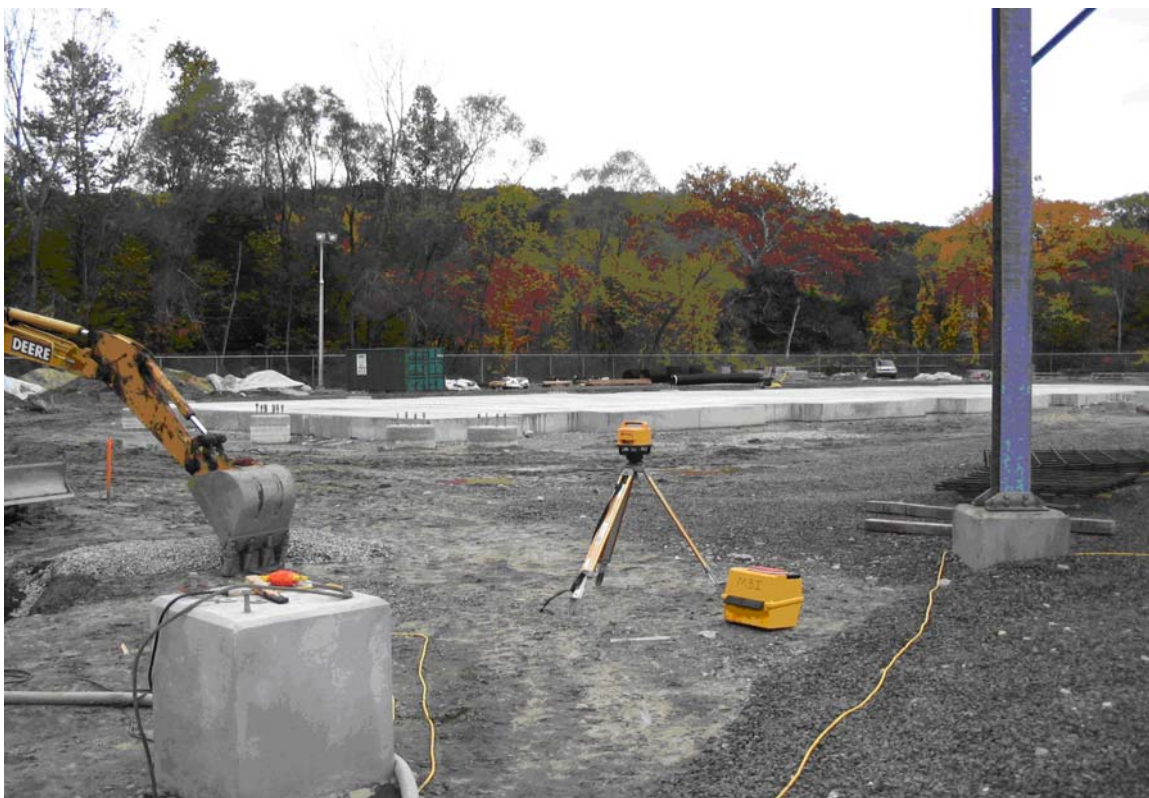
View of the concrete pad at Plumtree with the smaller footing excavation areas in the foreground. 10/21/04
